Automated Ceramic Tile Defects Inspection System Based on Texture Analysis

G.D.S Rangana and S.T. C. I. Wimaladharm
Uva Wellassa University, Badulla, Sri Lanka

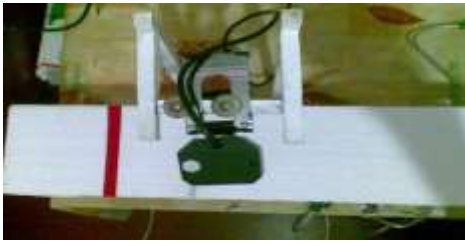
Figure 1. Mechanical component

Based on the output produced by the image processing system, the microcontroller and the camera are controlled. In this process camera takes a picture of the tile and send it to the image processing program. After analyzing the image, relevant signal is generated by the system and passed to the microcontroller to control the production line.

Due to the availability of pre-defined libraries for the implementation, Visual Studio framework has been used for implementation and 16F877A microcontroller is used as the controlling component.

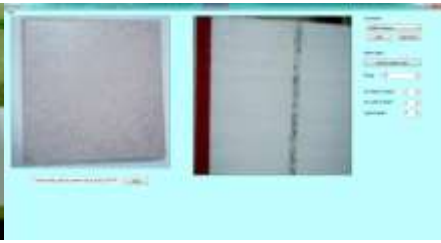
Figure 2. Software controller

Instead of human vision, computer vision system is used to classify the tile. First of all a picture of the tile is taken and image processing steps are applied to image. This stage includes pre-processing, image enhancement and feature comparison techniques. After getting the data consisting of the frequencies of masks, RULES-3 algorithm (Aksoy, 1993) is employed to determine the level of defect of the tile based on the features extracted and then pattern recognition is performed.
